# Ground motion characteristics of the 2015 gorkha earthquake, survey of damage to stone masonry structures and structural field tests

Parajuli, Rishi Ram ...[et al]. Ground motion characteristics of the 2015 gorkha earthquake, survey of damage to stone masonry structures and structural field tests. *Frontiers in Built Environment* 2015, 1: 23.

Rishi Ram Parajuli<sup>1\*</sup> and Junji Kiyono<sup>2</sup>

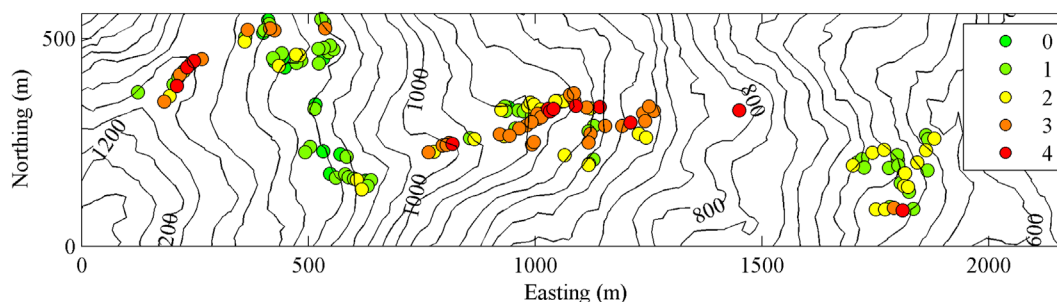
FIGURE 7 | Topographic map of the study area showing structural damage grade.

In the study cluster, there are 149 structures consisting of 58 large, 68 medium, and 23 small-sized buildings with 39, 46, and 15% of weightage, respectively. Damage grade and location were recorded using GPS at the site. **Figure 7** shows the damaged structures on a topographic map. Green colored dots represent grade 0 structures, whereas red dots represent the location of grade 4 structures (as we do not have any grade 5 structures). **Figure 8** shows the damage grade of structures with percentages of structures that include categories of structure sizes. We found that 8% of the structures had a damage grade of 0; 38% were in grade 1; and grade 2 and grade 3 structures were 24% each. The remaining 6% of the structures were damaged severely, at grade 4.

Here, we can see most of the structures fall under damage grades 1, 2, and 3, with less coming from grades 0 and 4. From the survey, we found that most of the buildings on ridge lines suffered heavy damage but those on side-slopes were not damaged as much. The study area comprises an area that includes a mountain ridge along with a local ridge line formed on the middle of the slope. Hence, we categorized the structures as ridge-line structures, those that are located on the ridge line. There are a total of 52 structures located on the ridge line, including the main and local ridge lines. Damage grade details of the structures on the ridge line are shown in **Figure 9**. There are no structures that fall under grade 0; in fact only 15% of the structures graded as 1 with 19% in grade 2. More than half of the structures, i.e., 52%, were grade 3 and the remaining 14% fell under grade 4. A small structure that was graded as 3 on the ridge line is shown in Image S1 in Supplementary Material.

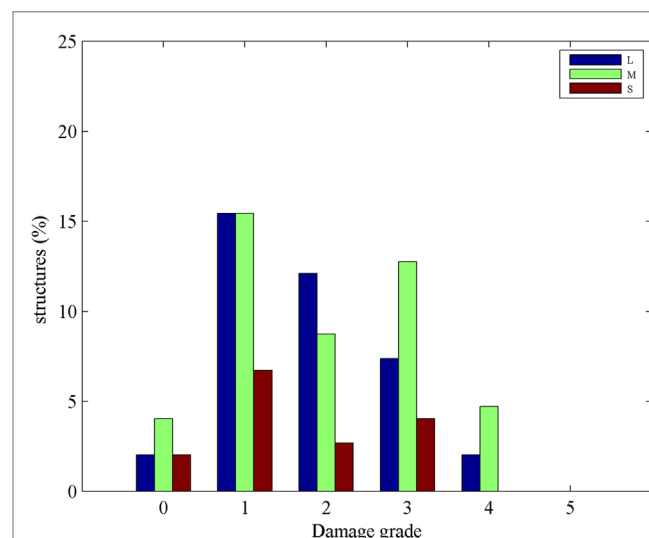
FIGURE 8 | Damage distribution for all structures.

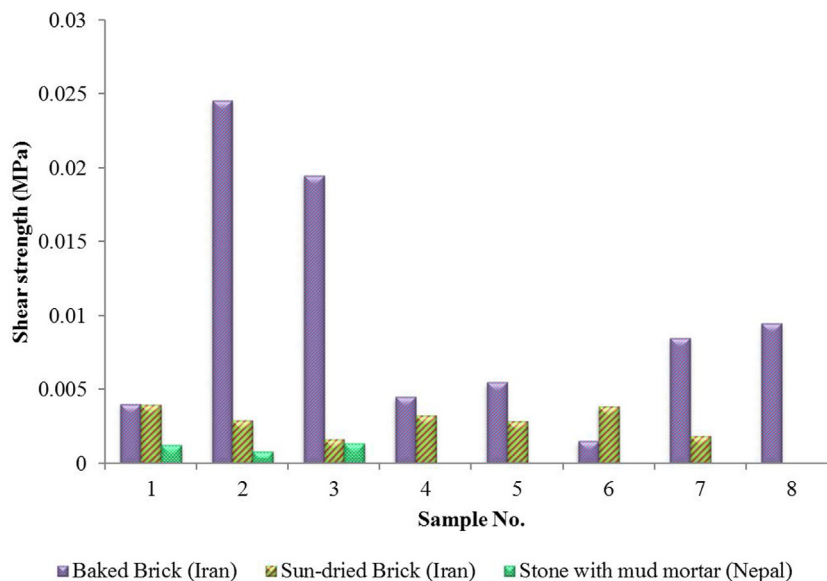
strengths of mortar bonding were estimated to be 0.0029 and 0.0097 MPa, respectively. The frictional coefficient for the joint was found to be 0.62 and 0.54, respectively, for sun dried and baked brick masonry. Test results from Nepal show that the frictional coefficient lies between the values of sun-dried and baked masonry structures in Iran, but shear bonding strength is much lower than that of both brick masonry structures.

FIGURE 10 | Comparison of the shear strength of stone masonry with mud mortar joint in Nepal with shear strength of brick masonry wall joints in Bam, Iran.

The pullout test conducted in damaged structures to find out the joint properties. Here, we compare the data with the test conducted in Iran after the Bam earthquake where the test was done similarly on the damaged structures. Shear strength of the joint from the test is very low that can be neglected for the modeling but frictional coefficient of mortar joint found significant.
